SEVENTEEN OF FORTY PAGES

A TWO WEEK STONEXCURSION IN NORTH WALES AND CUMBRIA

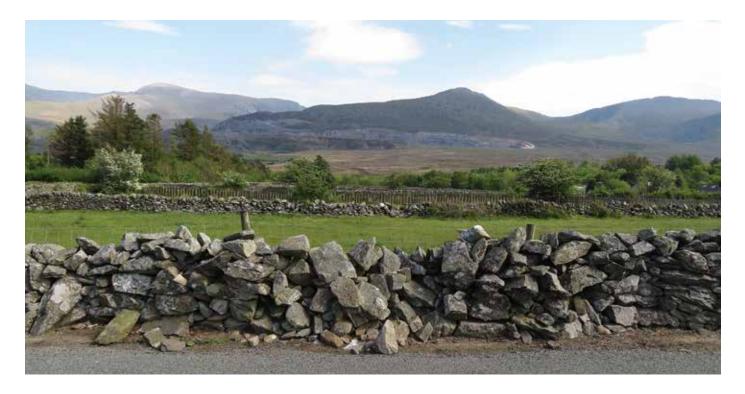
In North Wales there are stone walls galore. The boundary of every field, large or small, is marked by them and they border both sides of every road and lane. A large number of stone walls there are in some state of disarray, such as the one above and many have been repaired or rebuilt with varying degrees of skill. A few examples of well-built walls are shown on these pages. The one at the top of the facing page was done by Sean in his home village of Penisarwaun.

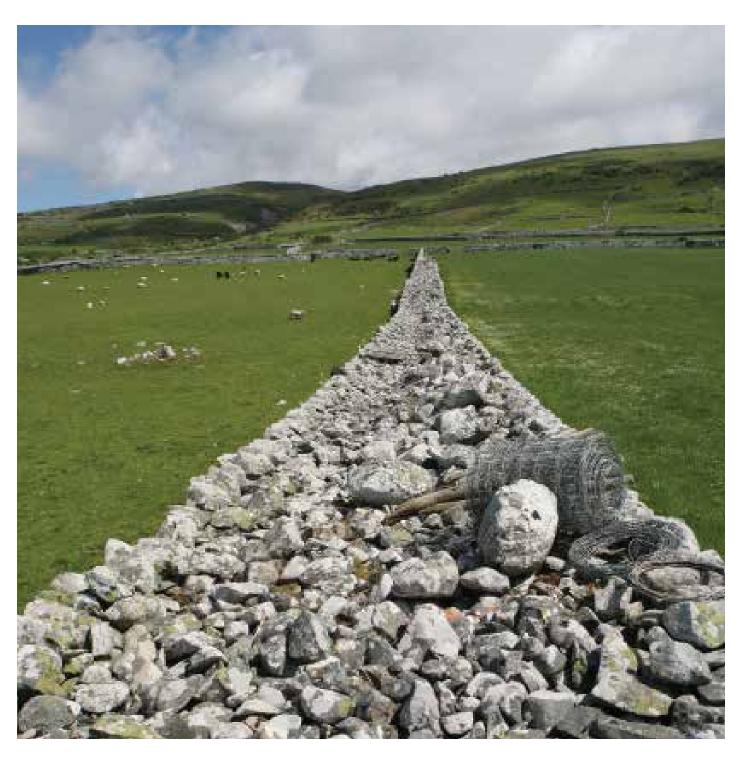
A megalithic CONSUMPTION WALL at Egryn near Harlech. Consumption walls can be found scattered throughout the UK, commonplace in some areas, only occasionally in others. Their purpose is, as their name implies, to literally consume the stone continually being cleared from the adjacent fields. This wall near Harlech at about 8 feet across is possibly the widest in north Wales, but it pales in comparison to the Kingswell dyke near Aberdeen in Scotland, at 27 feet, the widest in the UK.

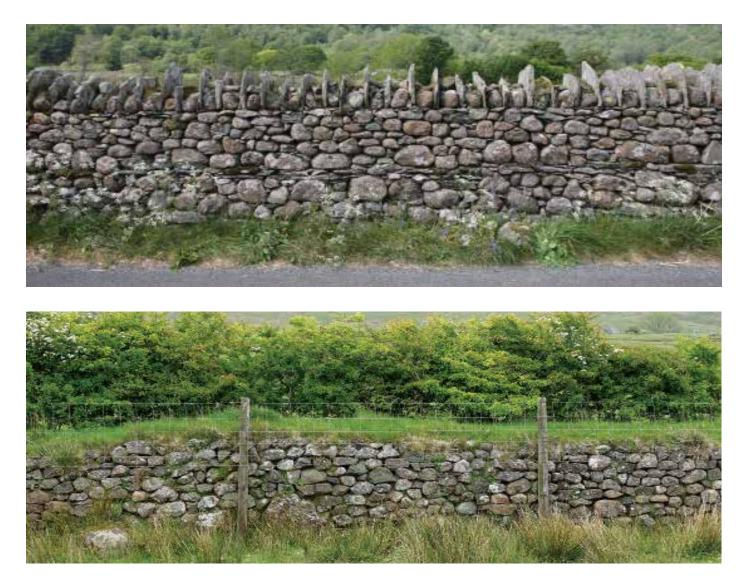
top: Roadside field wall near Dunnerdale, Duddon Valley. This style of coping with slates between rounded field stone occurs in a number of locations scattered around Cumbria.

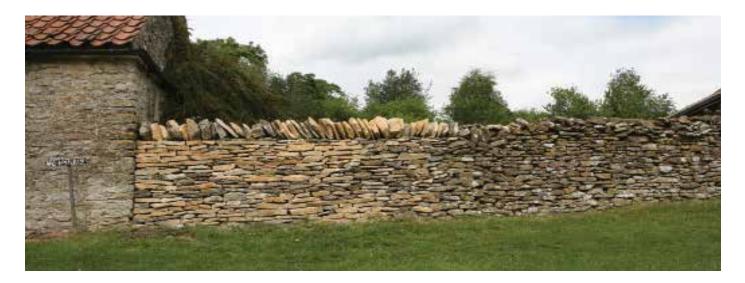
above: Stone-faced earth bank. Common in Cornwall and Wales (known as clawdd walls there) but a rarity in Cumbria. Not really

photogenic, but it deserves inclusion here as it is an effective style of walling. The hedge growing from the earthen core increases its height and makes it stock proof. below: This wall repair is actually in neighboring Yorkshire. It is shown here because the distinctive new work matches the earlier work and demonstrates that the future of dry-stone walling is in the hands of capable artisans.

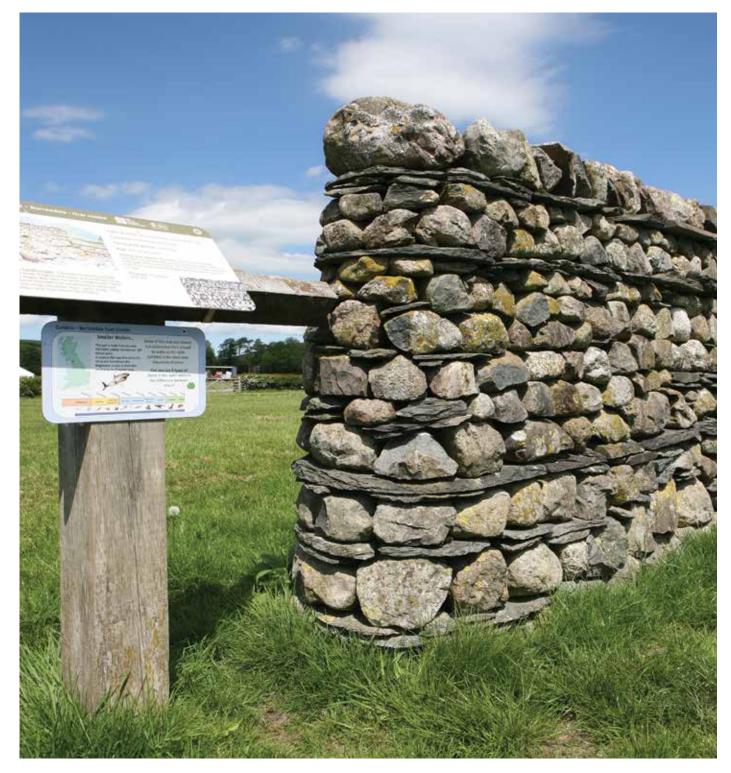
Cumbria is home to the *Dry Stone Walling Association* of the UK and our first stop upon arriving in the county was to visit the DSWA Center at Lane Farm, Crooklands in Milnthorpe, Cumbria. After a very welcoming cup of tea and a chat with Coordinator Alison Shaw, we walked up the road to inspect the dry-stone walling specimens displayed in a nearby field. This feature is very like the DSWA's Millenium Wall at the National Stone Centre in Wirksworth, Derbyshire.

The Millenium Wall is composed of sections of dry stone wall-ing built by wallers from all over the UK using stones brought from their region in the style of walling peculiar to that region. In this case however the preponderance of the stone used and the wallers using it are from the north. The variety of stone and

styles, however, is striking.

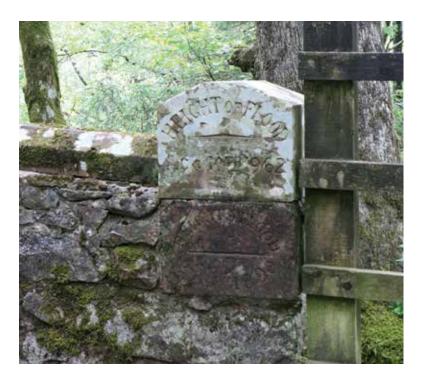
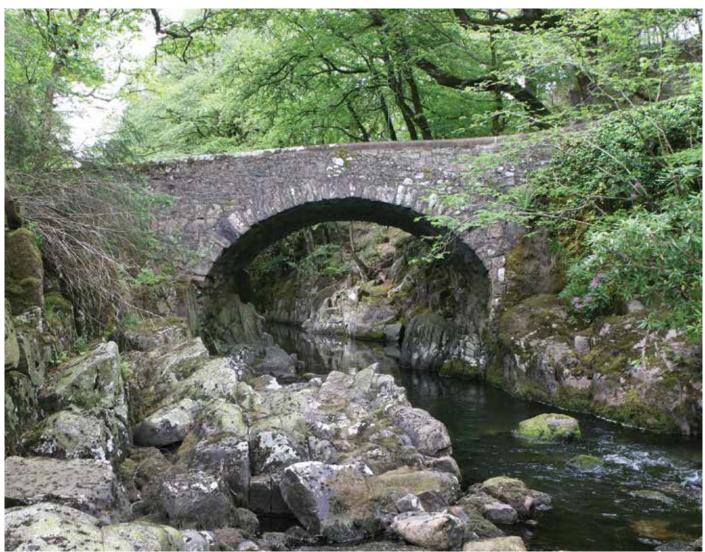
The TROUGH HOUSE BRIDGE

is located not far from the village of Boot in Eskdale. Probably a cart bridge originally, it is now a vehicular bridge with parapets. These parapets, added sometime after the initial construction, seem to be of a different stone, one not local to the area.

A band of granite constricts the Esk River at this point, making it a conveniently narrow place to build a bridge, but also a place that is liable to flooding. Two stone markers bear witness to major floods that the bridge withstood in 1890 and 1962.

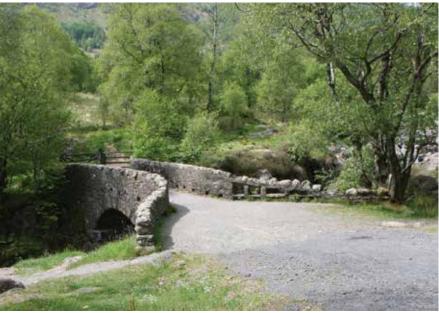
BIRKS BRIDGE

This bridge is near the hamlet of Birks. The name derives from birches which are particularly common trees in the area.

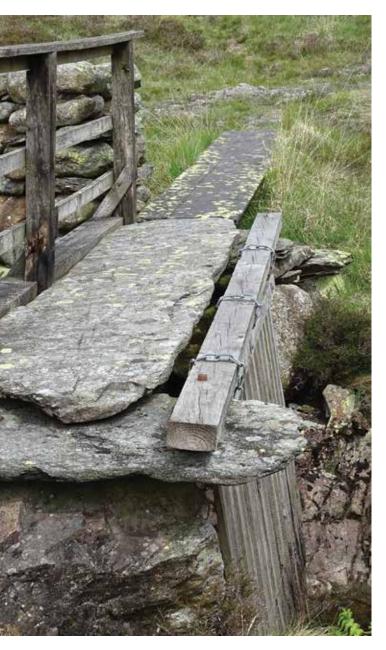
in Little Langsdale is a former packhorse bridge across the Brathay River. Admirably built of slate slabs and natural boulders in the 16th century, its use by by workers in a nearby quarry led to its name. The metal hand rail is a later addition.

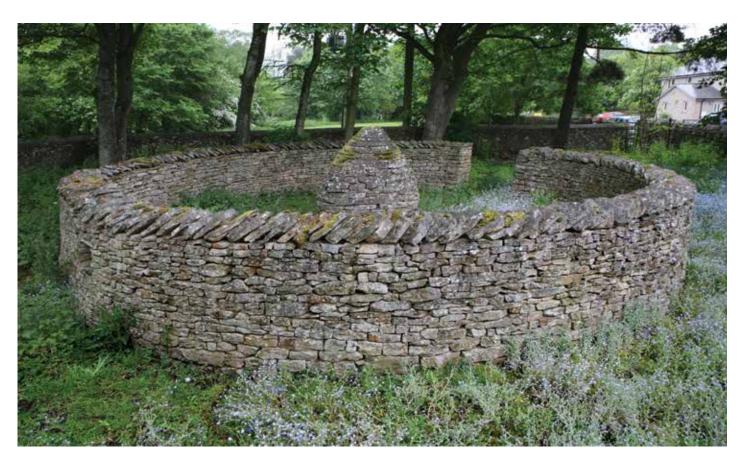
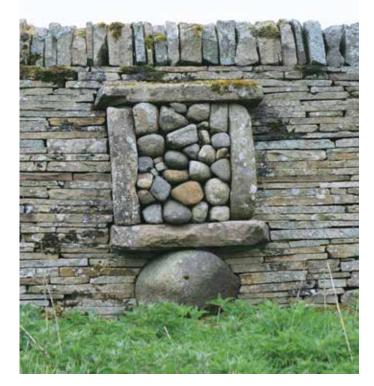
ANDY GOLDSWORTHY is from Cumbria and it is where he did a series of installations relating to a local phenomenon: the sheep folds—stone enclosures for holding livestock. From 1996 to 2003, assisted by traditional wallers, he designed and directed the rebuilding of 46 folds, in each case adding or incorporating sculptural elements such as those shown in the photos below and the top right corner of the facing page.
